CONNECTICUT RIVER BASIN  
WESTFIELD, MASSACHUSETTS

POWDERMILL BROOK  
DETENTION DAM  
MA 00605

PHASE I INSPECTION REPORT  
NATIONAL DAM INSPECTION PROGRAM

AUGUST 1978

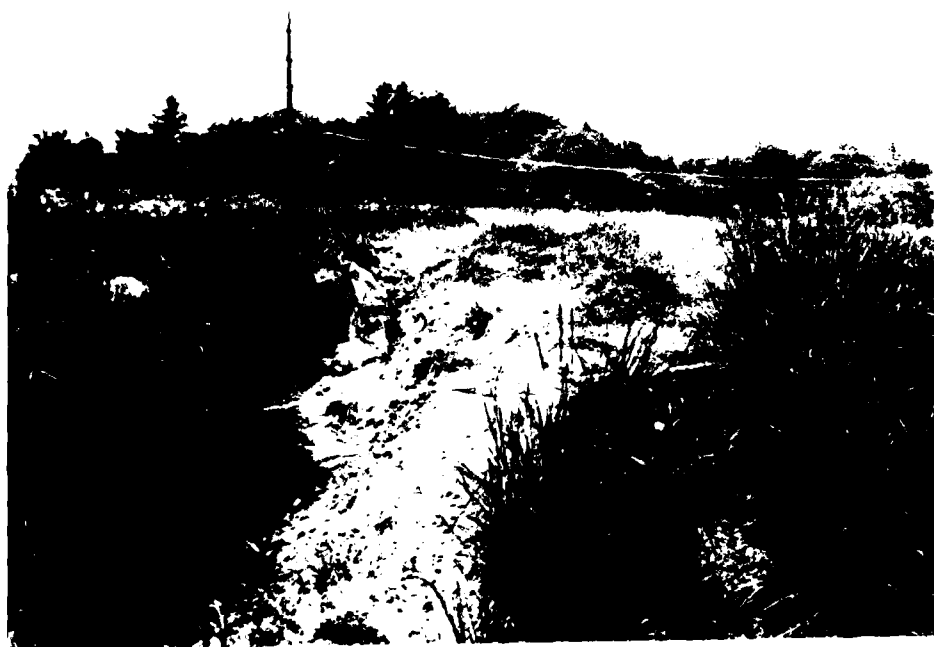
The crest of the dam has no pavement. Vehicular traffic has caused erosion on the crest which can be seen in Photos 1 and 2\*. The erosion is very bad at the left end of the crest where it contacts the spillway slope. This area is shown in Photo 2.

PHOTO NO. 2 - Erosion on end slope from dam crest to spillway floor

(1) Repair surface erosion channels at abutment/embankment contact and on the upstream and downstream faces.
